CHURCH POINT HOMEOWNERS ASSOCIATION

RESERVE STUDY

2011

Peter A. Burke, MSM, FMA, FMP

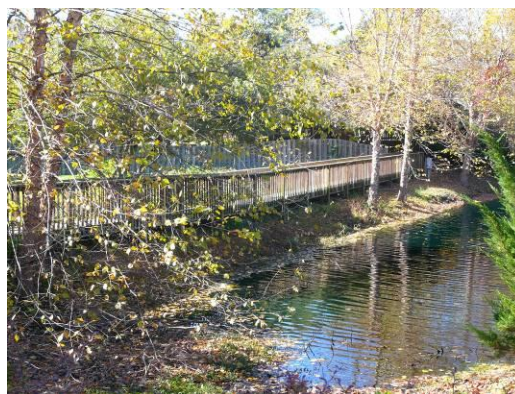
- Footbridge

It should be noted that there are two foot bridge's, one extends from the end of Church Point Place to the shopping center and a second shorter arching bridge from shopping center/restaurant to First Court Road. Based on physical indications, it appears the shorter bridge is used almost exclusively by shopping center tenants to haul trash to designated dumpster across First Court Road. There is no dedicated access to Church Point homeowners to this bridge. For purposes of this Reserve Study, only the longer, level foot bridge from Church Point Place is included as a capital item to be maintained by the HOA.

A similar question could be raised about the wooden footbridge. Would there be a decision made to perform a full scale 100% replacement of the wooden footbridge around the lake. If properly maintained, inspected and repairs made as needed, the bridge will last a significant long time and unless the HOA Board decides to replace the bridge with a new style or change the route/design, a full replacement would not be necessary in lieu of completing annual inspections and annual replacement of bad areas/maintenance/upkeep through operating reserves. Unfortunately, the risk of damage to the footbridge is greater than some of the other potential exclusions. Weather damage (tree falls on bridge) or vandalism are significant threats to large scale damage to the bridge. As such, it is recommended the footbridge remain in the Reserve Schedule such that should a major issue arise requiring significant replacement, the funding is planned for in the schedule and could be accelerated as necessary. It is also recommended that 10 cycle full refurbishments occur but not to exceed two cycles of refurb such that the third cycle would be full replacement.

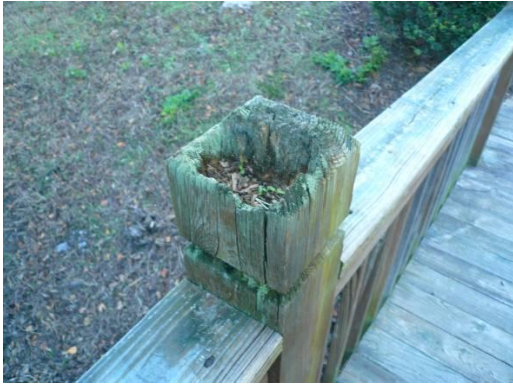
There are several areas currently in need of routine maintenance and upkeep. It is highly recommended that the above noted full refurbishments occur as soon as possible to maintain the assets. The schedule has been tailored to execute these projects over the next several years to extend the life of those areas and defer full replacement to later years. Full refurbishments will repair and replace damaged/deteriorated areas, clean and seal/protect them for long term exposure to elements and thus extend their useful life. Noted areas of concern are some rotted wood at the Gazebo and Commons Park irrigation building as well as:

Deteriorated wood on decorative rails and footbridge

Although the brick work is being removed, a large scale refurbishment project for the brickwork is recommended for inclusion as well as full refurbishments of the asphalt paths and the wood rails / footbridge. These large scale refurbishments are designed to return these components to "like new" condition as best possible and are far more inclusive and detailed than normal repairs and maintenance upkeep. These full refurbishments extend the life cycles of the noted components, thus extending their useful life before full replacement. These were presented to the Board of Directors and approved for inclusion in the schedule.

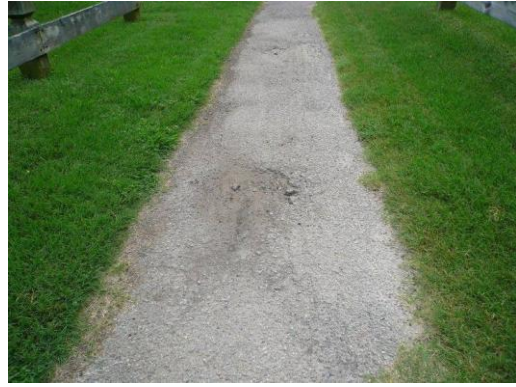
Potholes on asphalt paths as well as root damage
