Church Point Gazebo Repair Project

April 2007

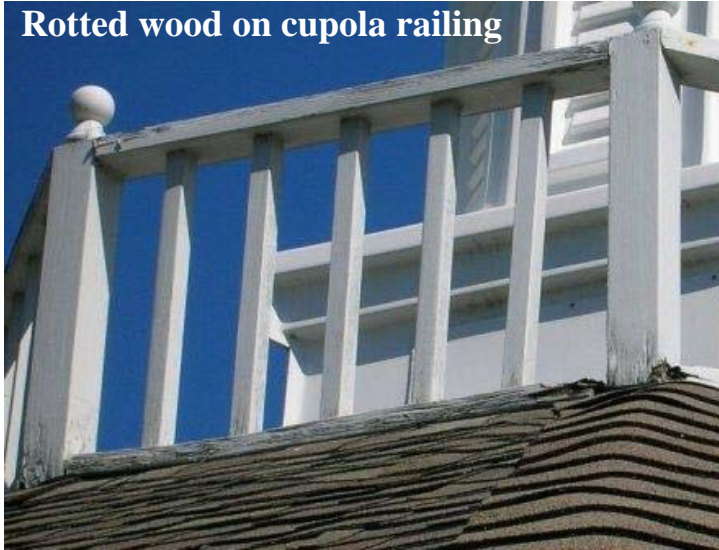
Rotted wood on cupola railing

- Disassemble railings on top of gazebo and remove existing membrane flat roof
- Install new EPDM rubber flat roof system on flat area on top of gazebo
- Reassemble railing and replace all rotten wood on railing including paint work
- Remove existing shingles on slop roof area of gazebo
- Replace any deteriorated plywood
- Install new GAF Timberline arc shingle system with felt underlayment
- Tear out all areas of deteriorated soffit, trim, and railing
- Pre-prime all wood before installing
- Install wood and caulk all joints
- Prep all areas and paint entire gazebo with high performance latex
- Power wash and stain gazebo floor and steps
- Cleanup and remove all related debris

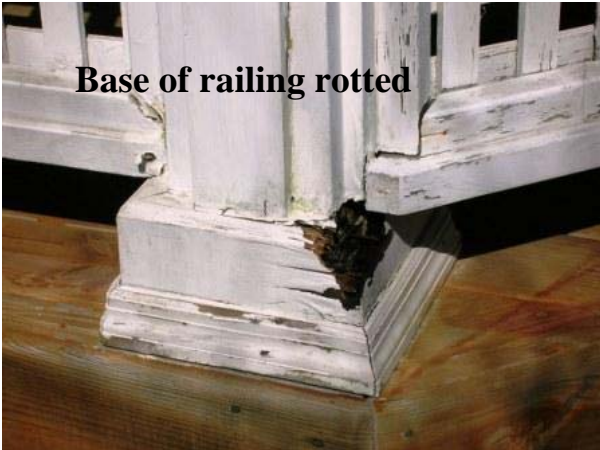
Base of railing rotted

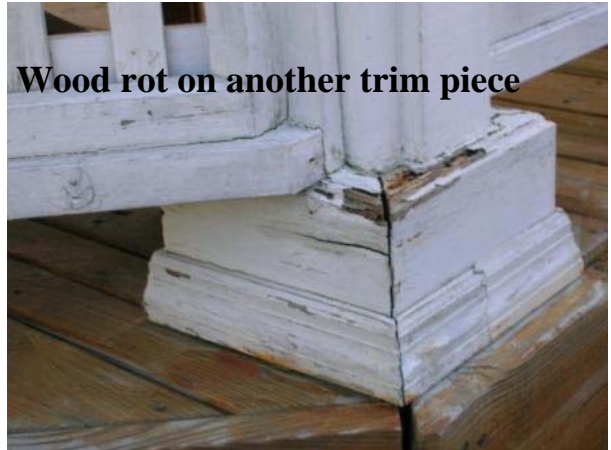
Wood rot on another trim piece
