CHURCH POINT HOMEOWNERS ASSOCIATION

FULL RESERVE STUDY

2023

VIRGINIA FACILITY SERVICES

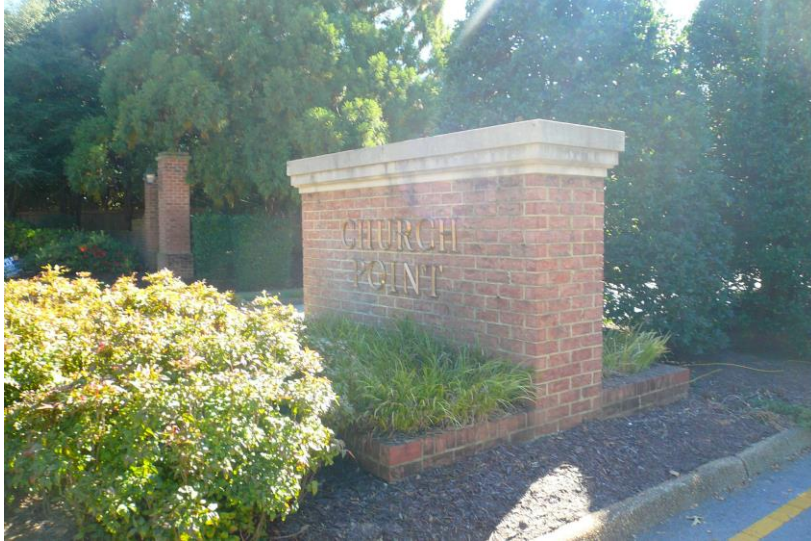
Main entrance sign is in GOOD condition but in need of power washing/sealing of the brick.

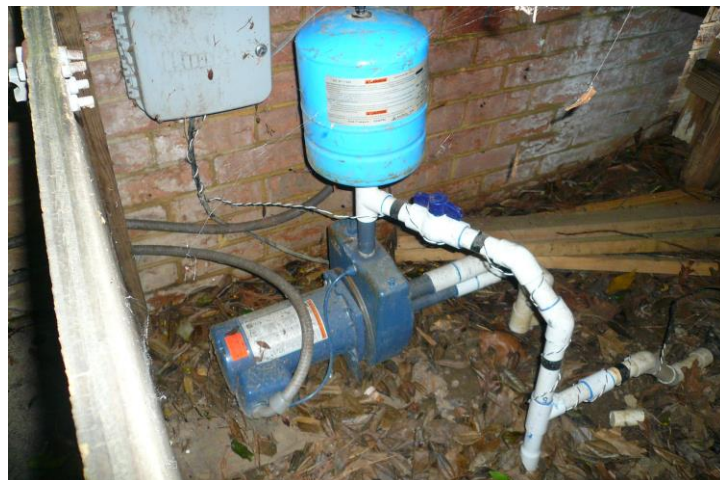
The irrigation pump system located behind the western wall is operational and in FAIR condition along with the wooden top cover that needs maintenance/repair.

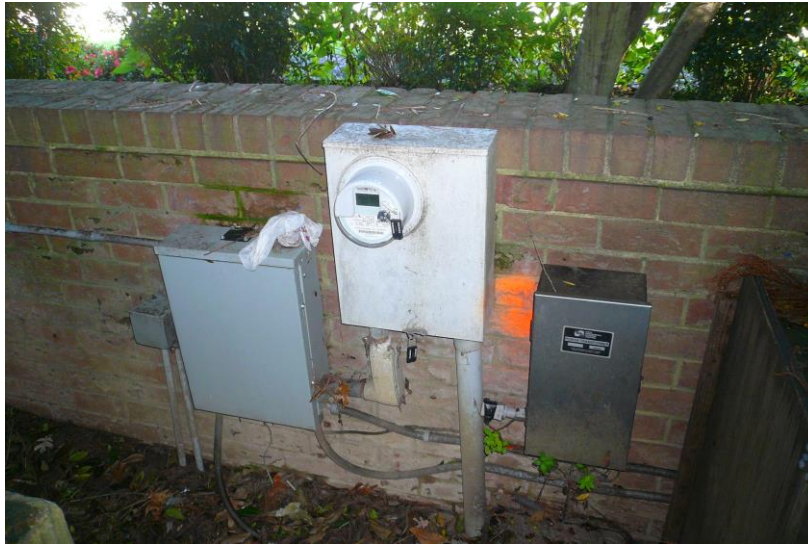
The electrical distribution box is in POOR condition. The Power Meter and Landscape lighting transformer are in GOOD condition (just dirty).

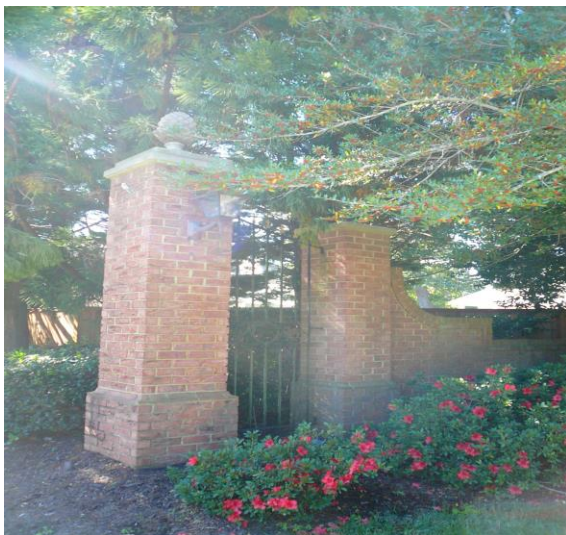
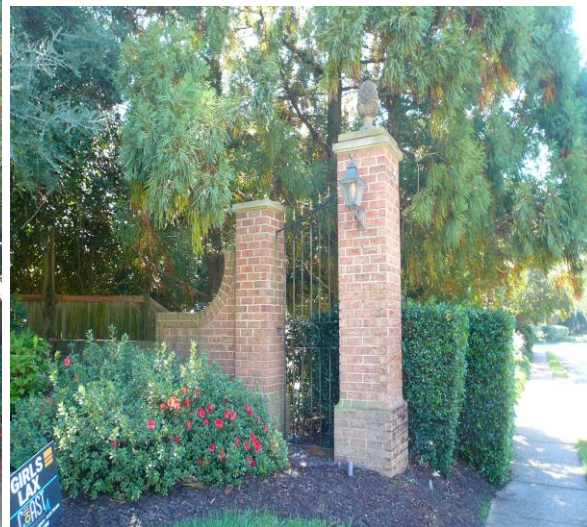
The brickwork is in GOOD condition but in need of power washing and brick sealing. Lanterns needs cleaning and east side needed to be re-lit at the time of inspection (gas discharging).

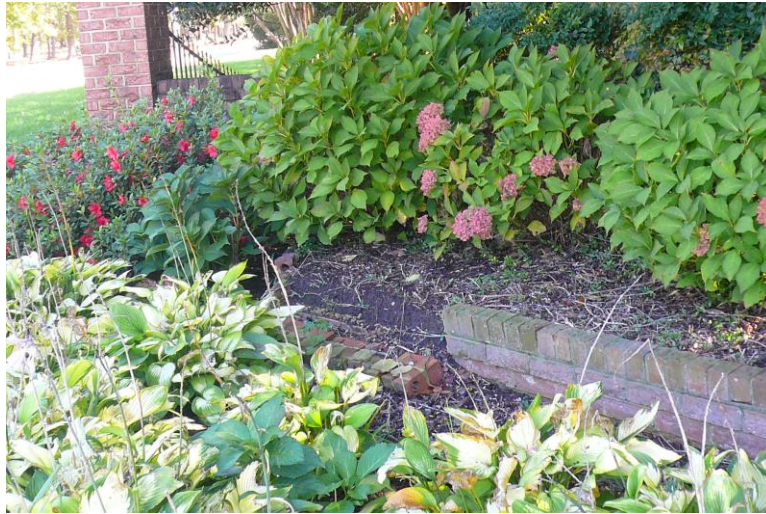
The east side planter raised area is in POOR condition with a section of brickwork that has fallen off.

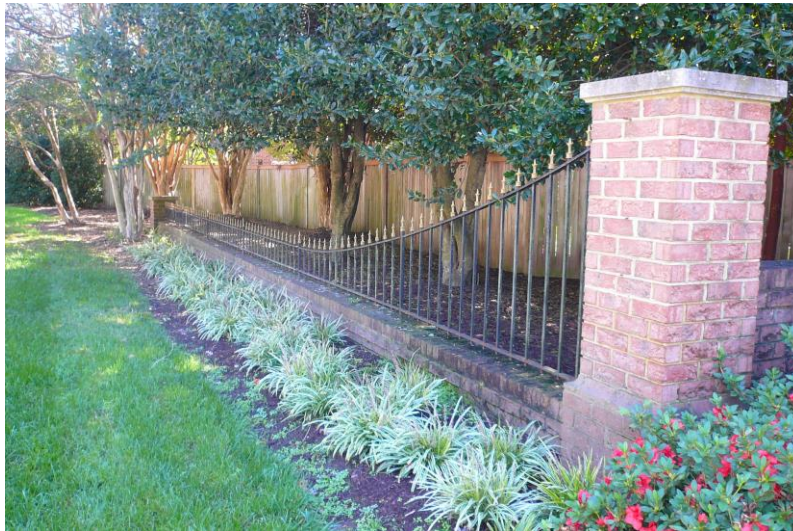
The ends of the brickwork are in GOOD condition but need pressure washing and brick sealing

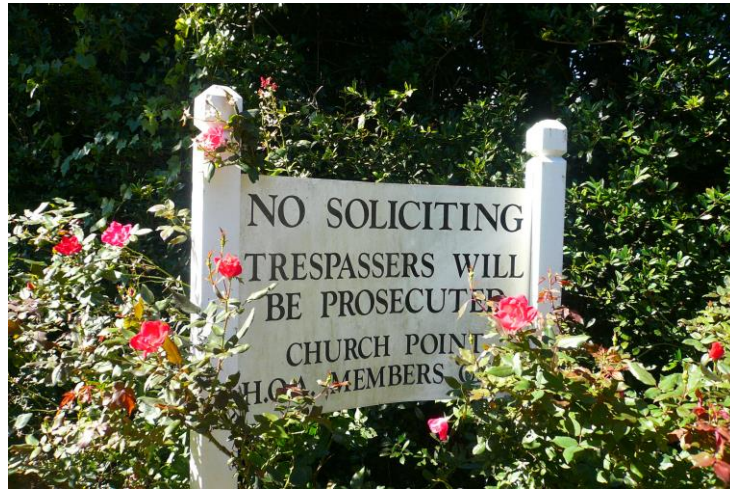
The Main Entrance sign is bent from vandalism and needs to be corrected or replaced.

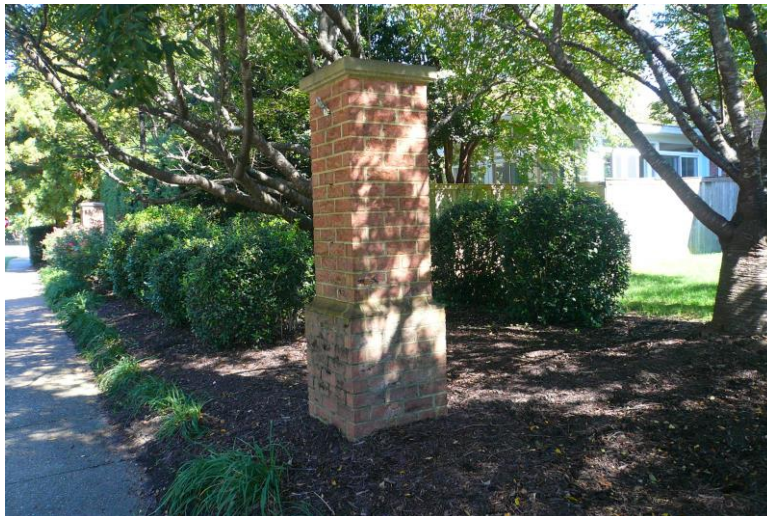
Entry drive lane side columns are in GOOD condition but in need of cleaning

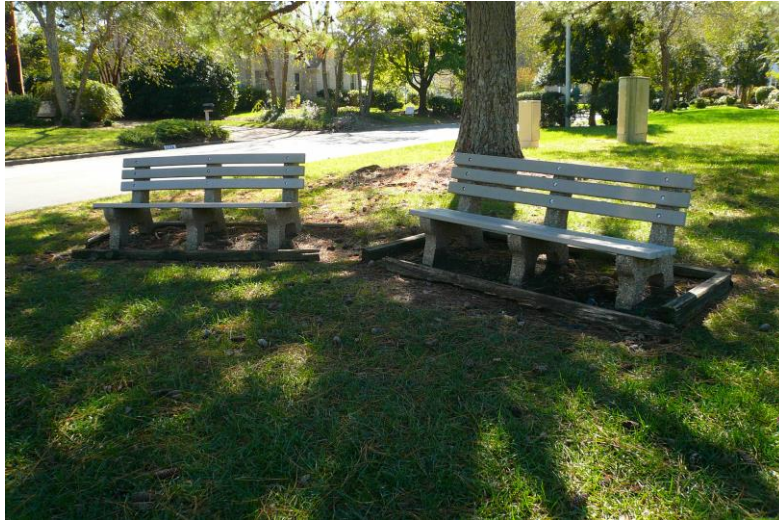
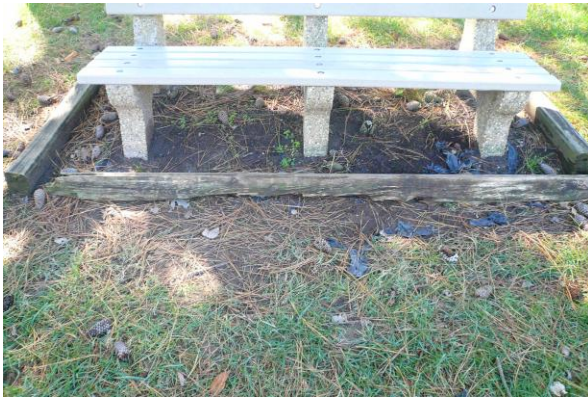
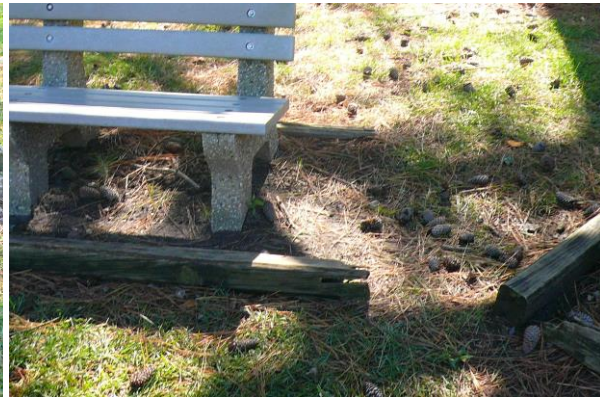
East end bench seating are in GOOD condition needing to be cleaned but the base perimeter wood (not a reserve item) needs to be replaced with sections rotting and missing

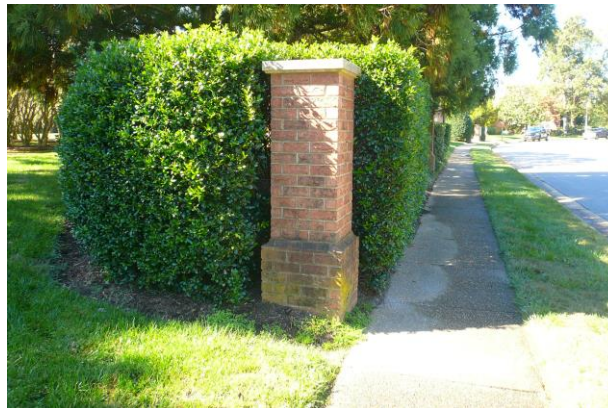
Columns are in GOOD condition needing to be cleaned.

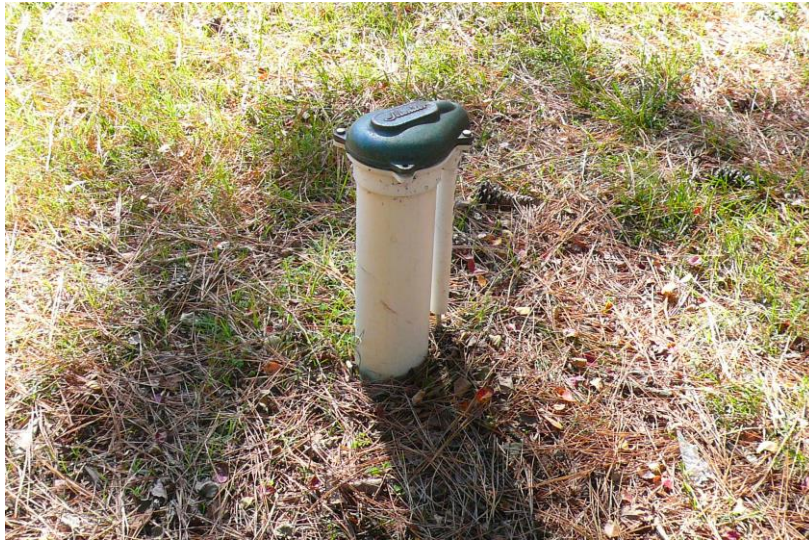
The inground irrigation system is operational (currently winterized) but is recommended to have a cover over it like a fake rock to prevent it from being hit or damaged.

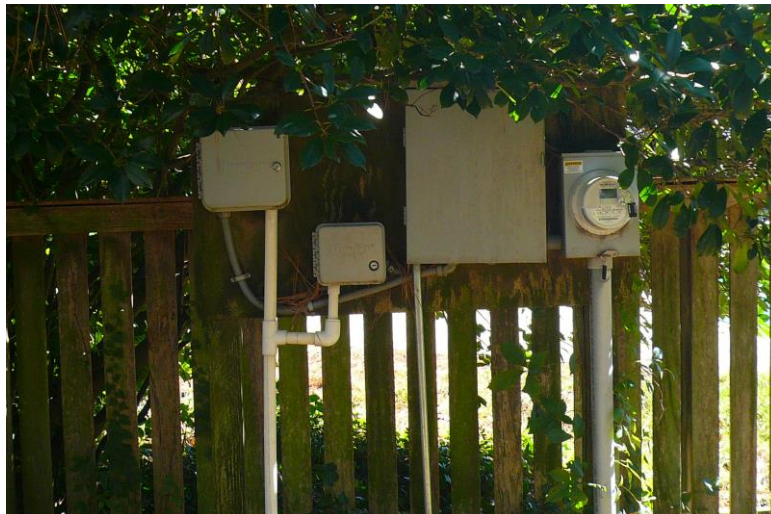
The irrigation controller and power distribution are in GOOD condition but the adjacent trees should be pruned back and the wooden board needs some TLC.

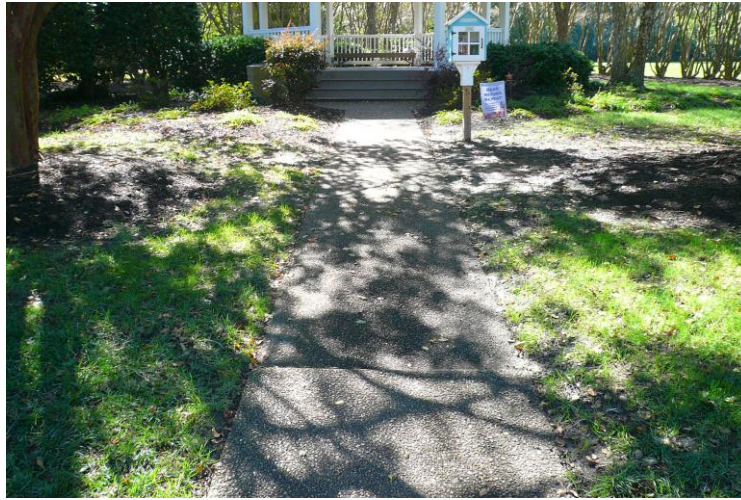
The Gazebo path is in GOOD condition but could use a cleaning

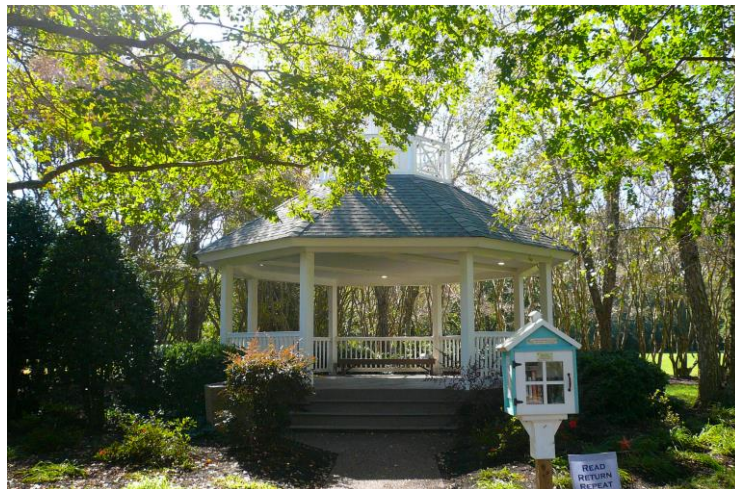
The GAZEBO is in GOOD condition after recent roof leak repairs and copula repairs.

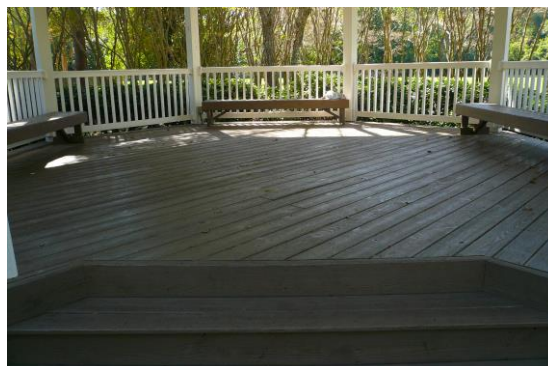
The deck boards, rails and seats were recently refurbished but continual annual cleaning and maintenance are recommended.

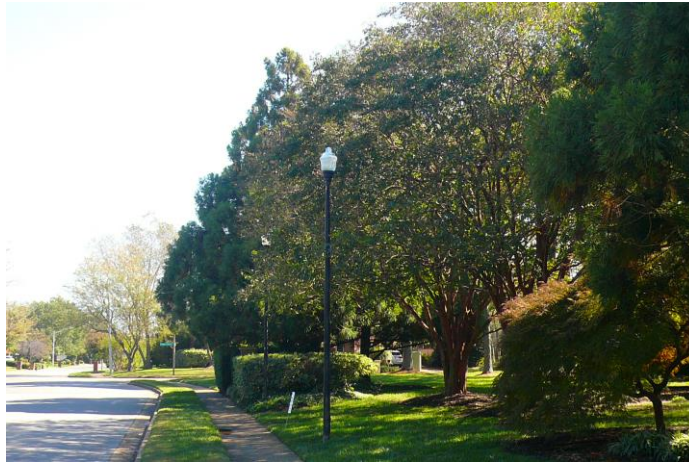
The light poles are in GOOD condition but two bulbs are currently out at time of survey – east pole at gazebo and the first pole on the outbound lane right side.

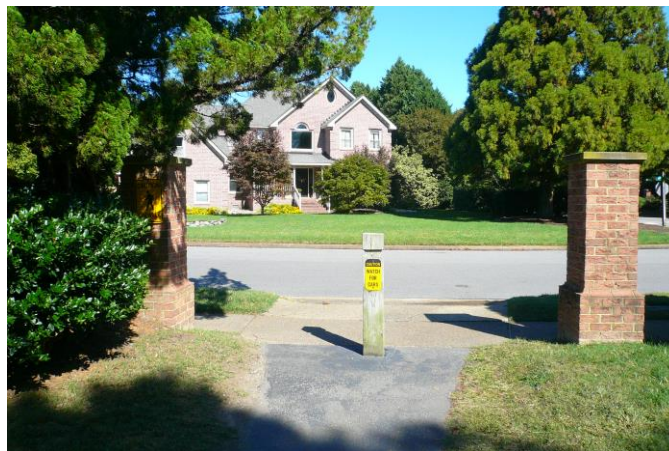
Gazebo path signage is in GOOD condition but adjacent overgrown trees should be pruned back.

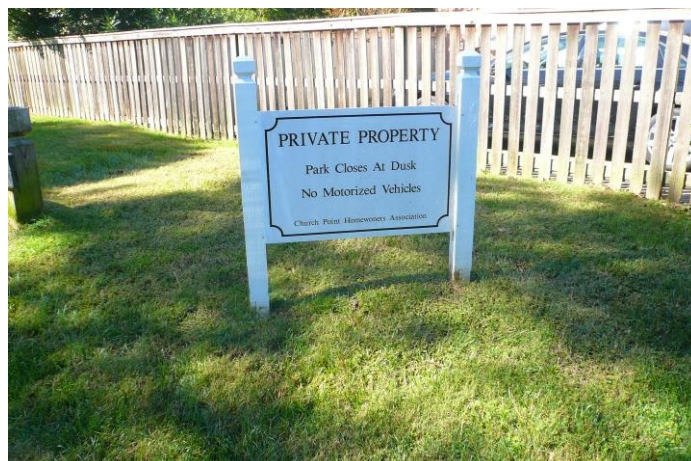
Park signage is in VERY GOOD condition having recently been replaced. Weed wacker string is damaging the base of the posts – recommend a stone perimeter border or similar.

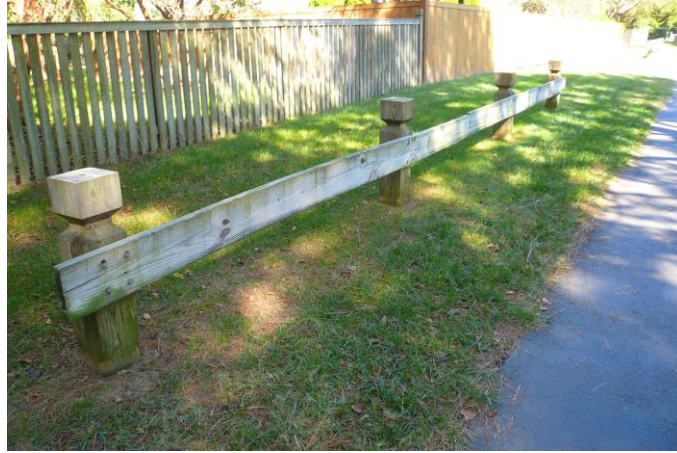
The wooden rails were in GOOD condition at the time of the report. Previously the rotted wood post tops were covered with a copper cap that were repeatedly vandalized. The rotted post tops were then cut off to reveal flat top. These flat tops need to be treated with wood sealer to reduce water damage in the future.

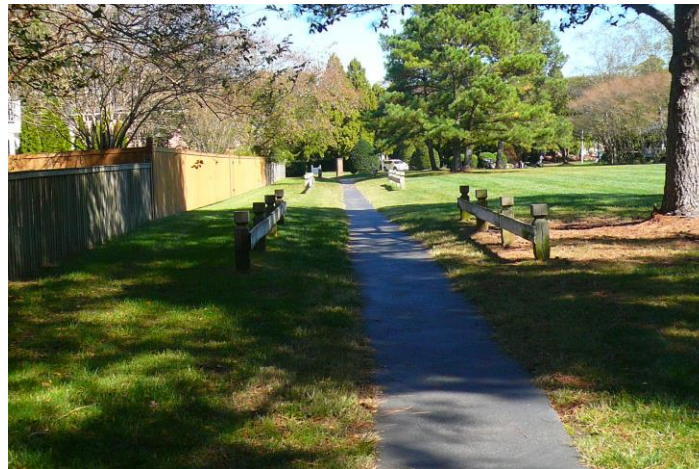
The asphalt path is in GOOD condition

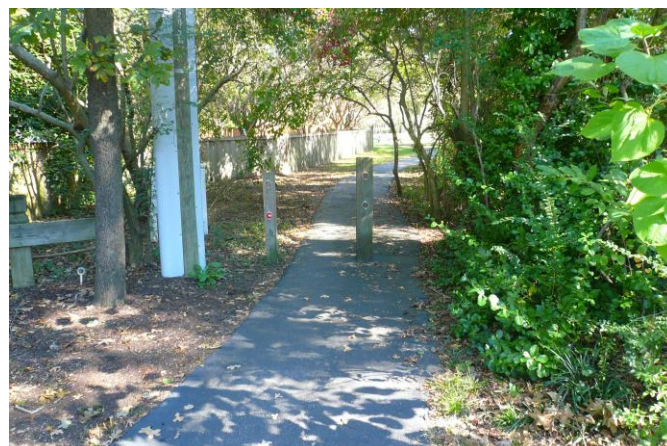
The Thoroughgood end of the path has reflectors on the wood posts that need to be replaced.

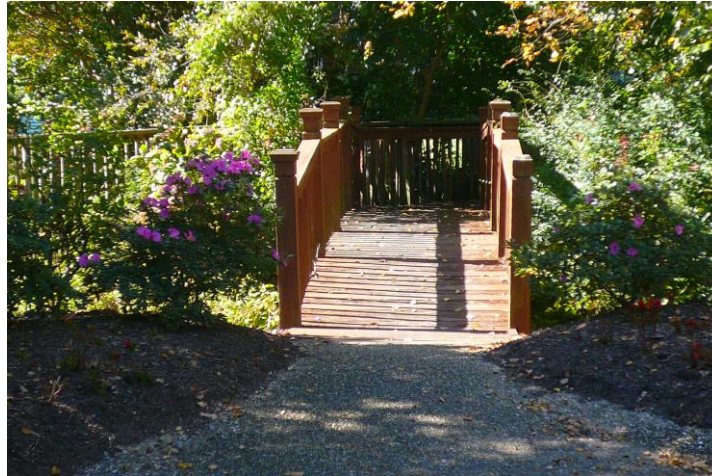
The foot bridge was refurbished not too long ago with rotted deck boards replaced and railing along with staining / sealing. Maintenance and cleaning needs to occur regularly but the bridge is showing age and wear and is in FAIR condition especially related to the railing posts.

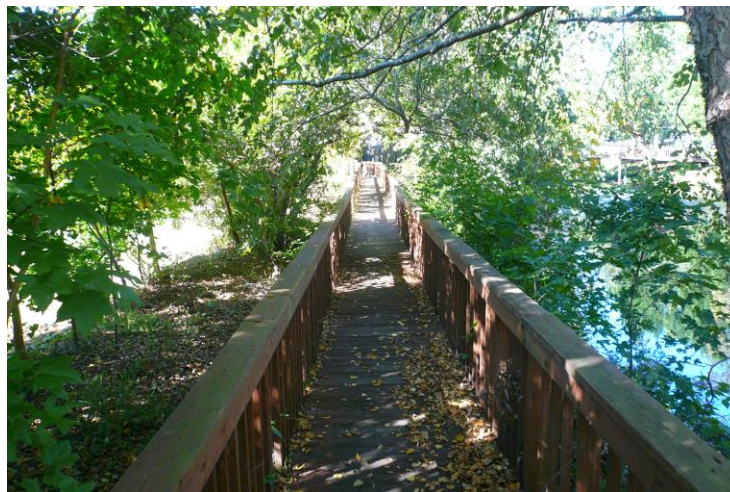
The landscape company should be maintaining the bridge for overgrowth (especially poison ivy during season). There is a light band along the south side of the railing that needs a new photo cell timer and several sections were noted to be out when turned on. Recommend replacement of the rope lighting.

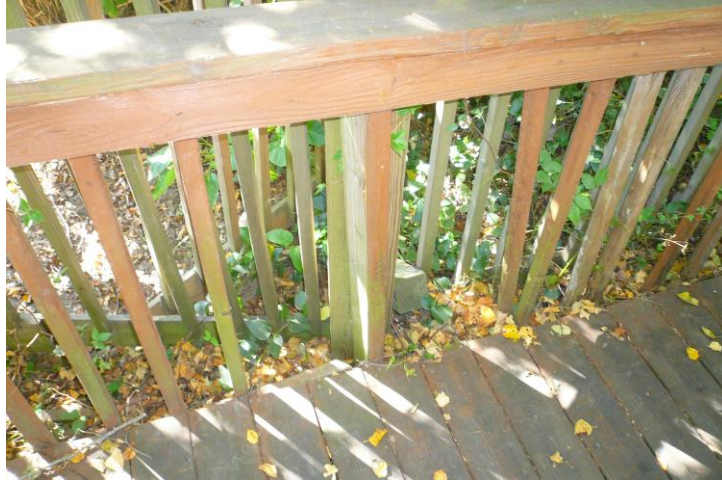
Several railing pickets are broken in the same area of the bridge turn - appear to be from bikes taking turn too fast.

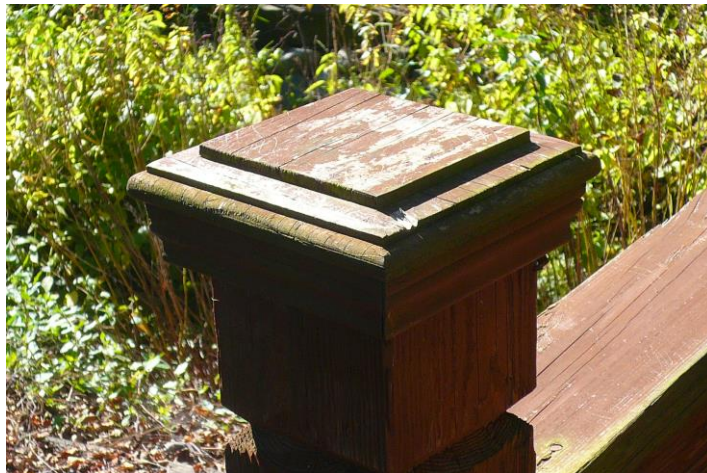
Railing post caps were installed a while ago to reduce amount of top post weather decay.

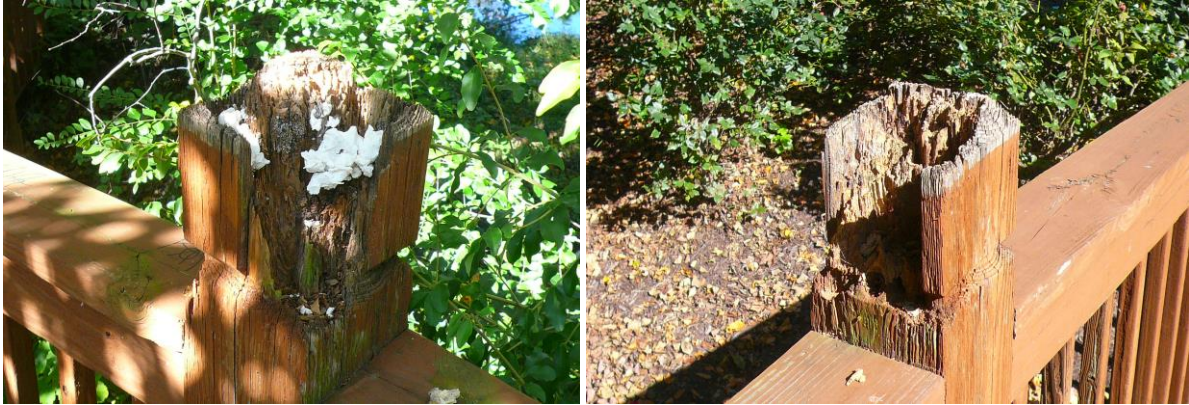
Several caps are missing and the wood rot is now excessive on these posts. These post tops need to be cut off or the entire post replaced.

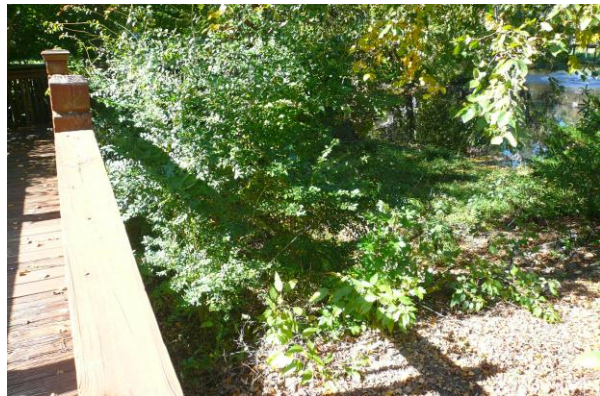
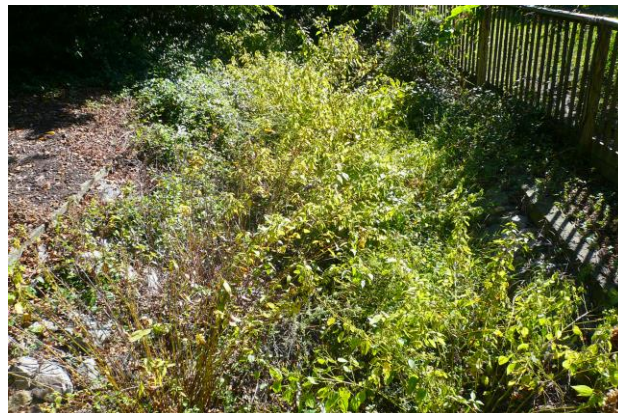
The storm water run-off trench from Thoroughgood to the lake is maintained by the City but heavily overgrown. Church Point excavated and installed RipRap several years ago to reduce erosion (the city installed concrete walls farther down the trench also). The riprap needs to have the vegetation removed and the bottom of the trench cleared of all weeds and debris. The inability of water to flow has led to flooding issues in the past.

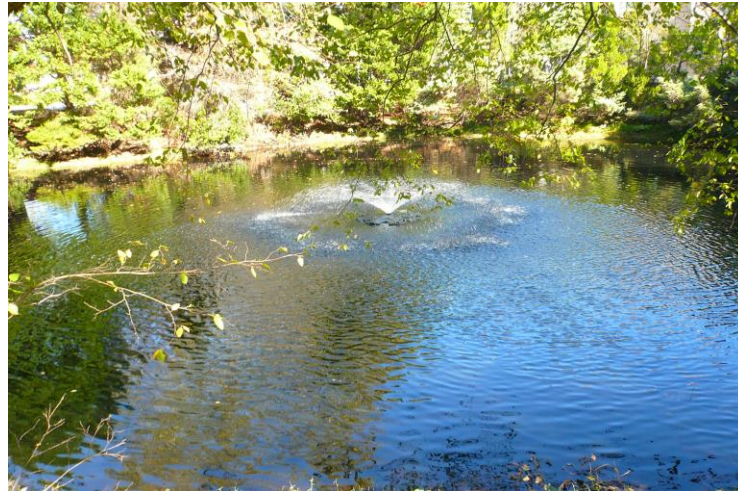
The lake aeration fountain is in GOOD condition and fully operational at the time of the survey. It should be noted that the power distribution box is shared and several circuits tapped for use by the restaurant resulting in breaker trips in the past turning off the fountain. This should be monitored, and the fountain reset when it occurs since the fountain is critical and required for the lake that is actually a BMP.

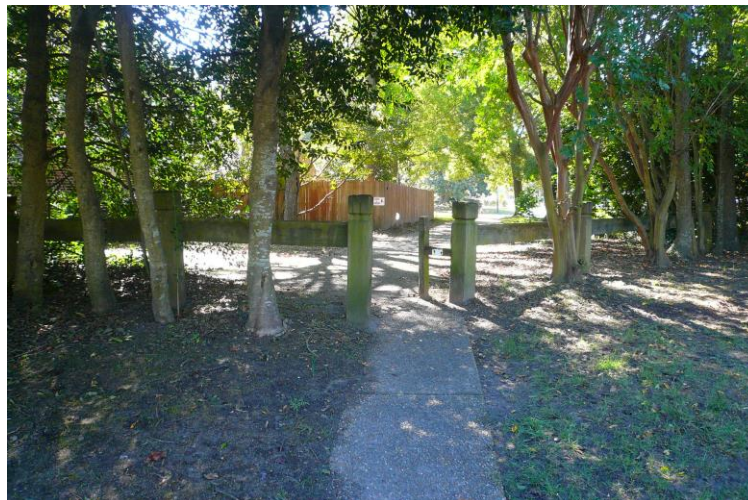
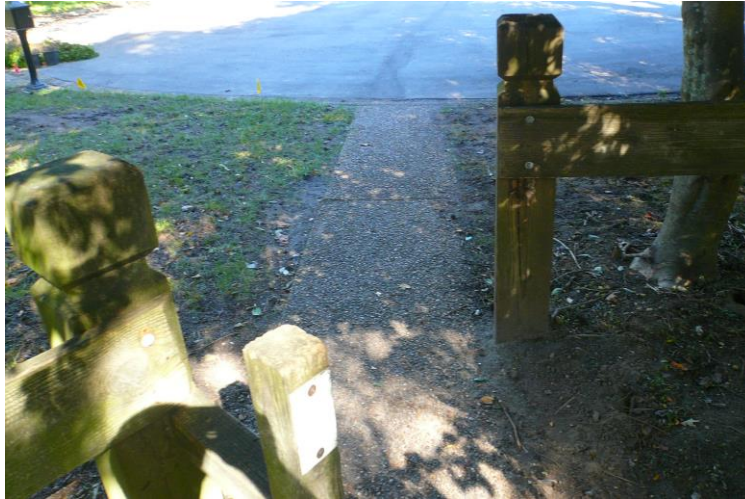
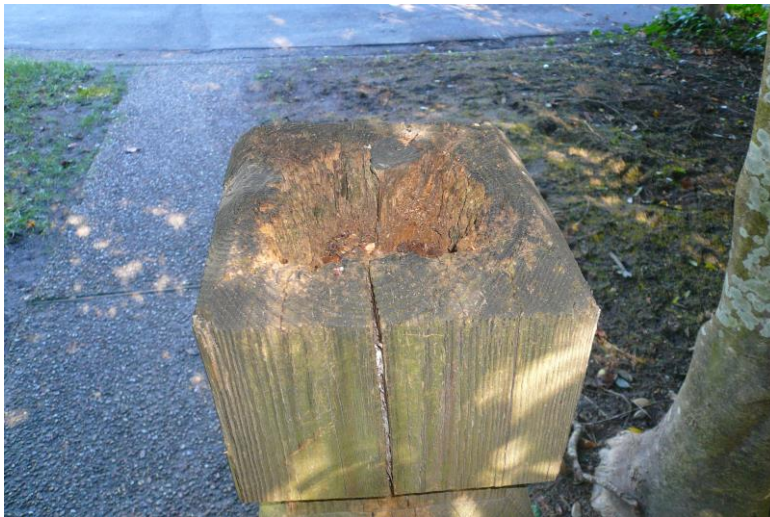
The path and wooden barriers are in FAIR condition overall but the top of the posts are rotting and reflectors should be installed on both sides of the posts.

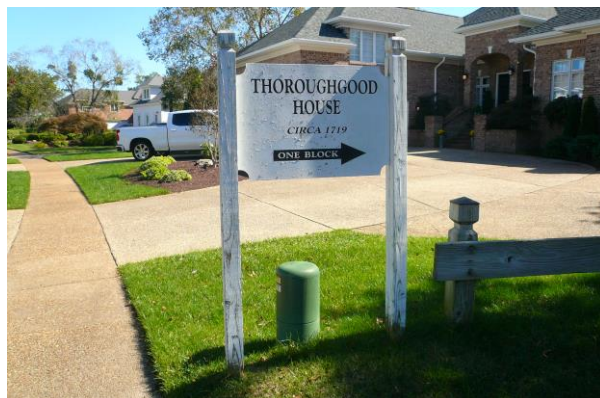
The wooden sign is at end of service life and should be replaced like the gazebo path sign recently was.

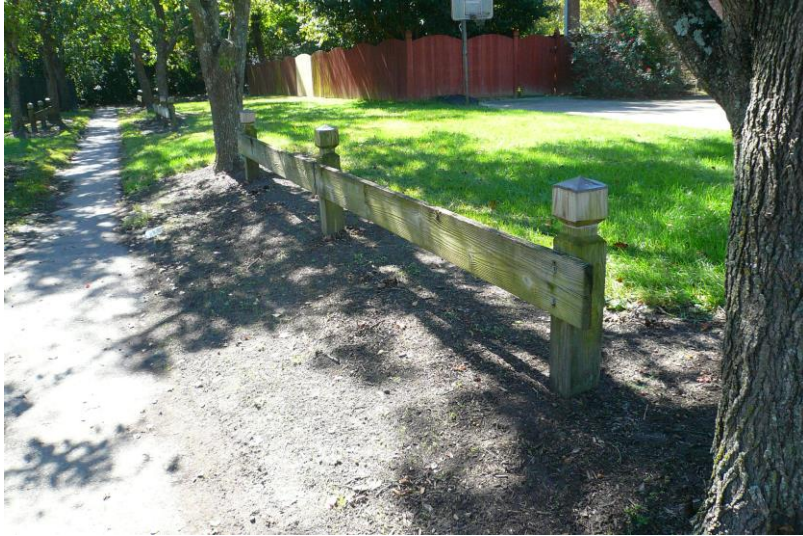
The Railing is in GOOD condition, the copper post caps are still in place reducing the commonly seen top post decay.

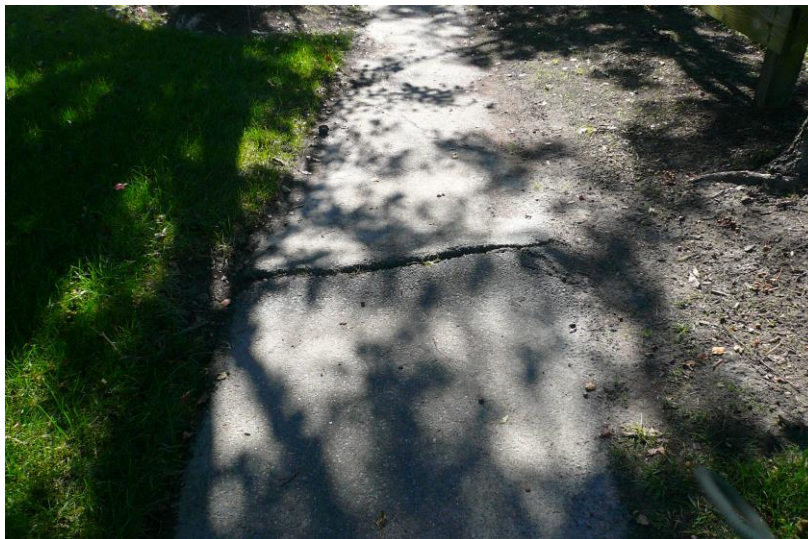
The Asphalt path is in POOR condition – root uplifts need to be cut out and the asphalt patched. This is a trip hazard liability for the association.

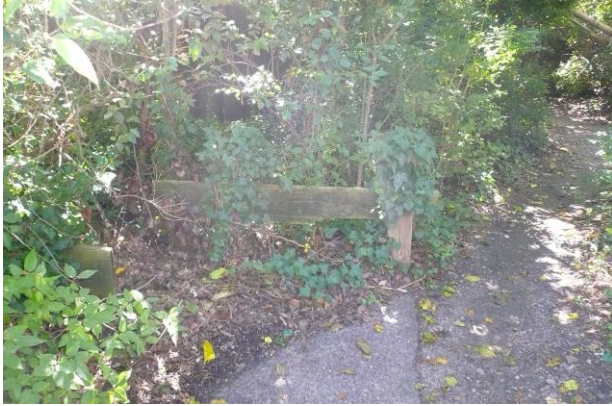
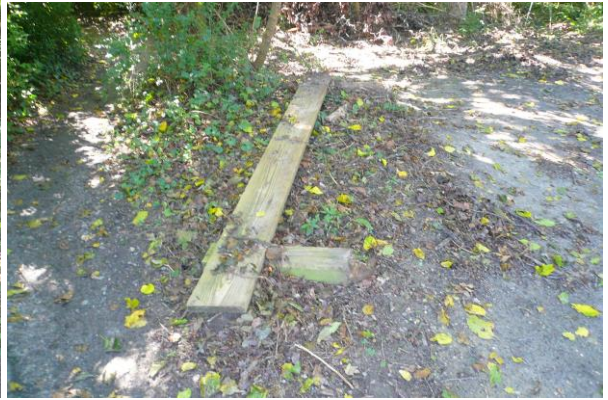
Sections of the railing at the Thoroughgood end of the path where the Church Point asphalt ends and the remainder of the path, on the Thoroughgood side, is dirt are in POOR to FAILED condition with sections broken on the ground or overgrown with vegetation.

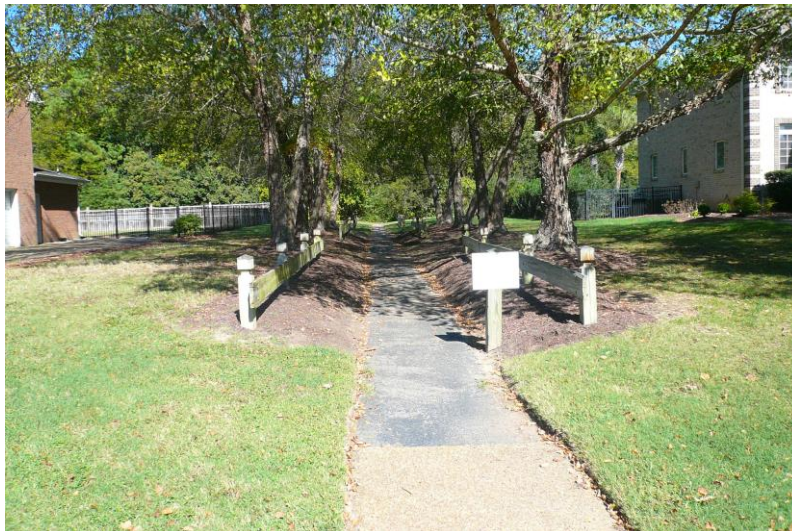
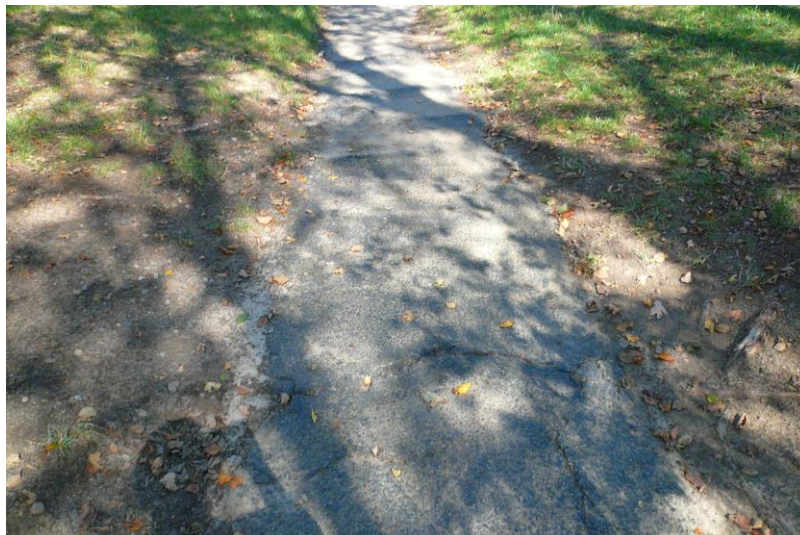
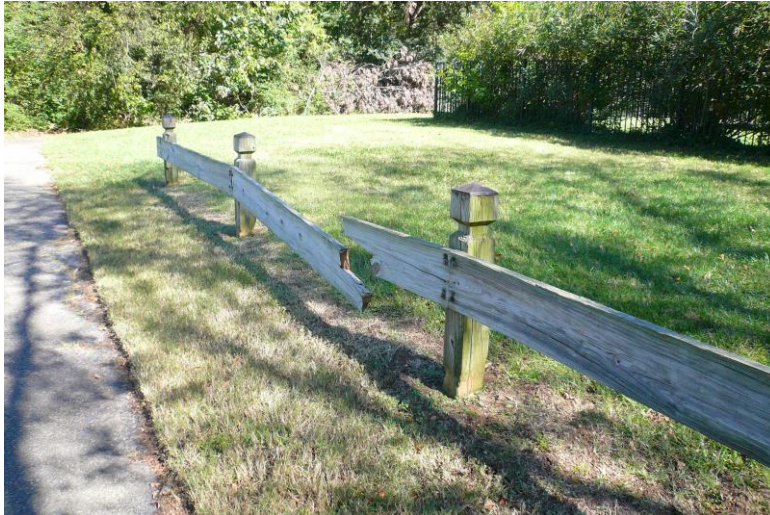
This asphalt path is in **VERY POOR** condition with multiple root uplift areas that need to be cut out and replaced. This is a liability for trip hazard. Additionally the railing is in **POOR** condition with a broken section needing to be replaced.

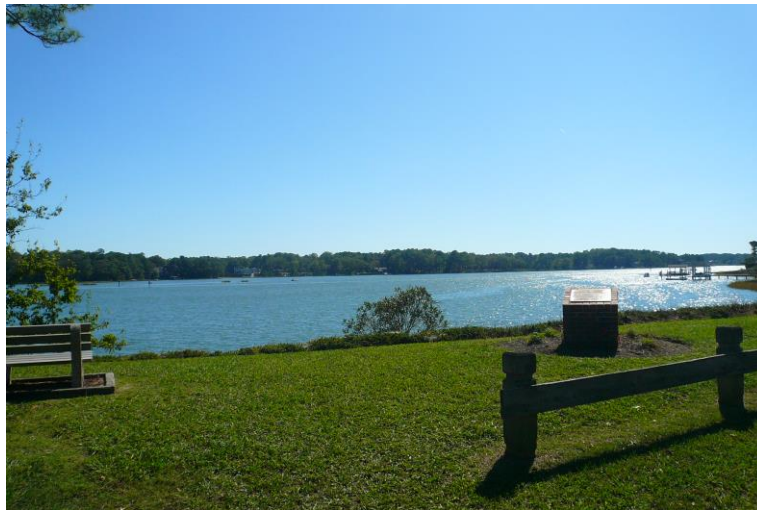
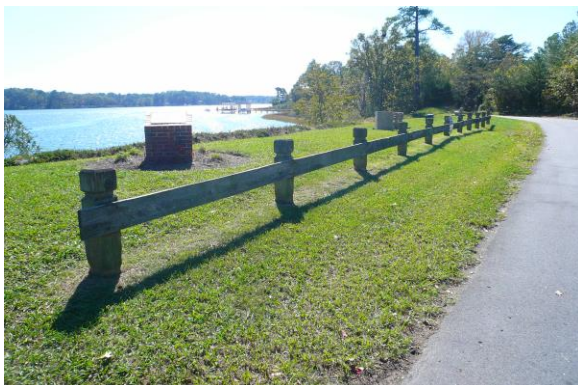
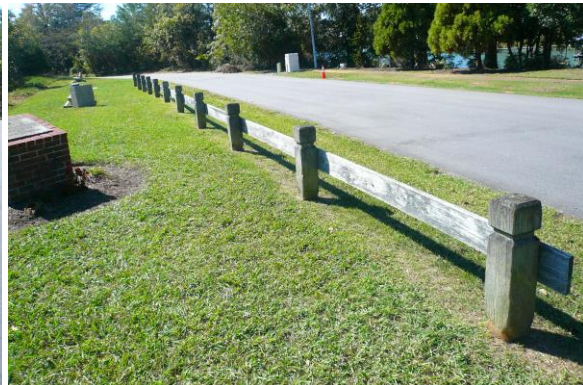
Overall, the waterfront is in **VERY GOOD** condition related to the seating and rails along with the brick monument structure (brick needs cleaning and sealing).

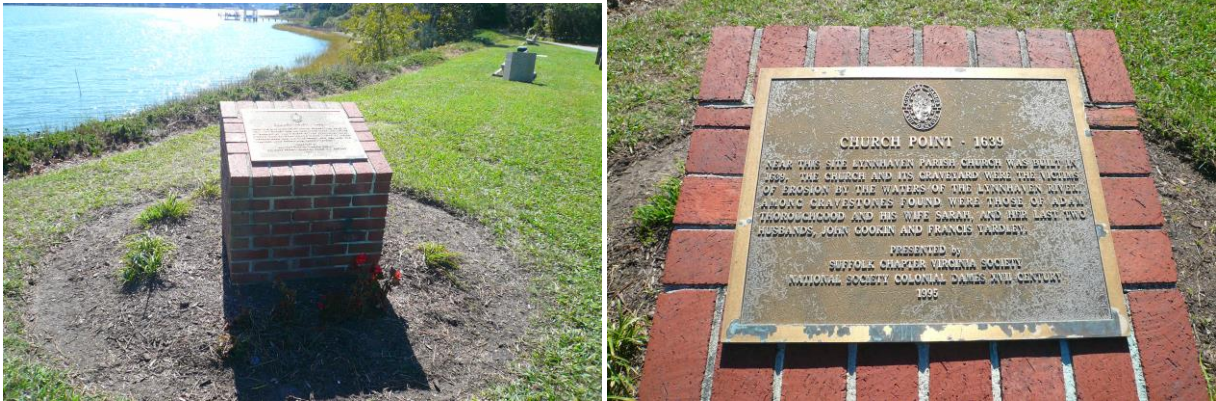
The monument plaque is in need of cleaning and refurbishment

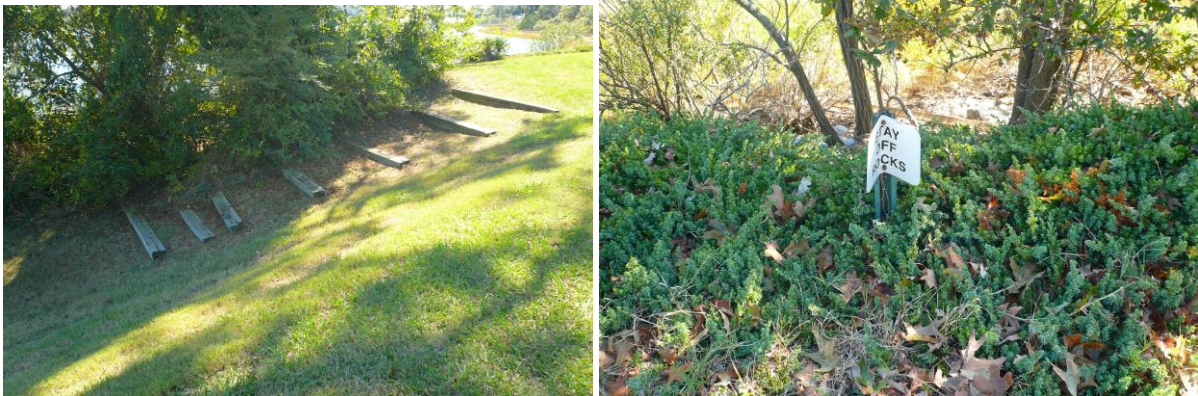
The steps to the lower level need to be replaced and signage needs to be replaced.

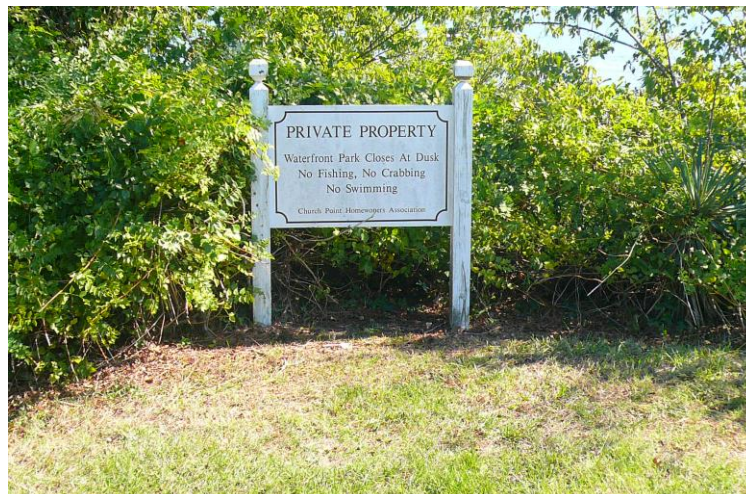
The main waterfront sign is in GOOD condition needing some maintenance (clean and paint) and adjacent shrubbery pruned back.
